**EXPERIMENTAL INVESTIGATION OF THE  
INTERACTION OF MOISTURE, LOW TEMPERATURE, AND  
LOW LEVEL IMPACT ON GRAPHITE/EPOXY COMPOSITES**

PREPARED BY  
K. N. LAURAITIS  
P.E. SANDORFF

**LOCKHEED-CALIFORNIA COMPANY  
BURBANK, CALIFORNIA**

FINAL REPORT  
OCTOBER 1980

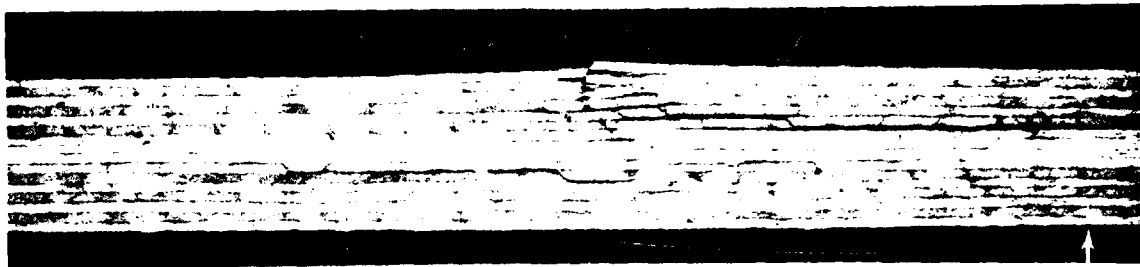
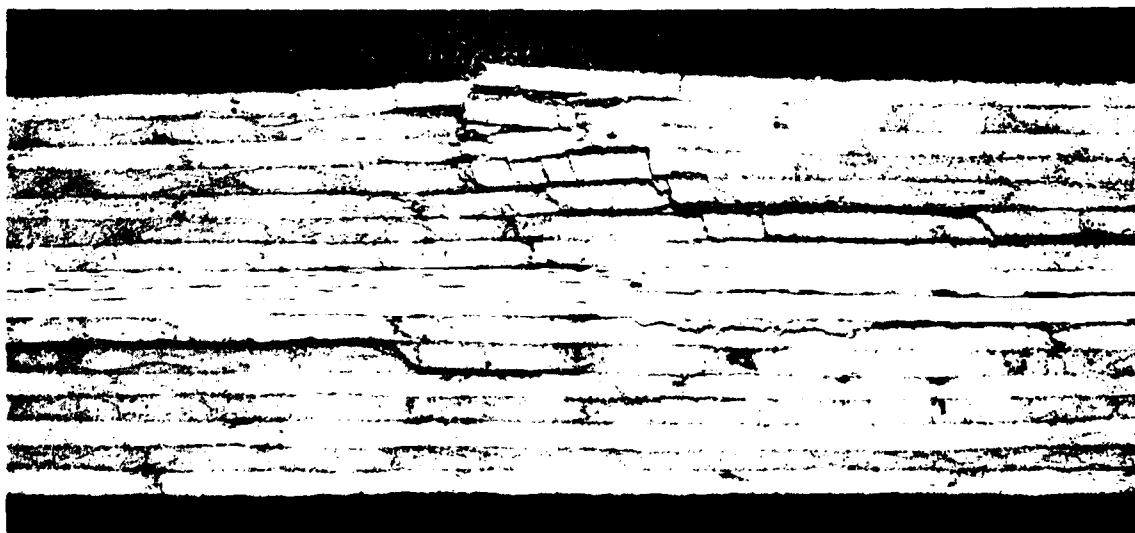
Figure 5-4: Micrographs on Section 1 from Impact Location 1. (a) 10X, top to bottom: Impact, Melting, Cracks, and Fracture. (b) 25X, top to bottom: Fracture, Cracks, Melting, and Impact.

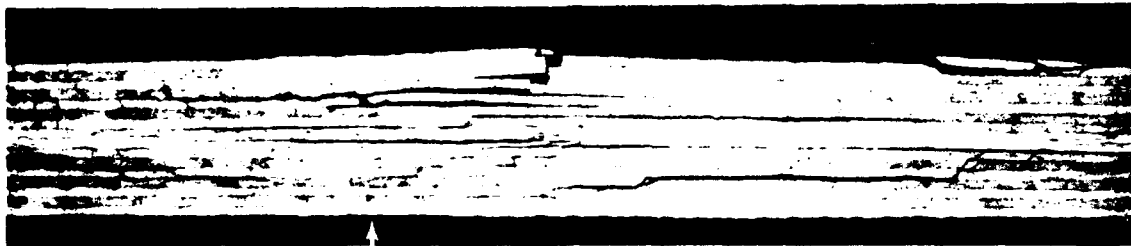
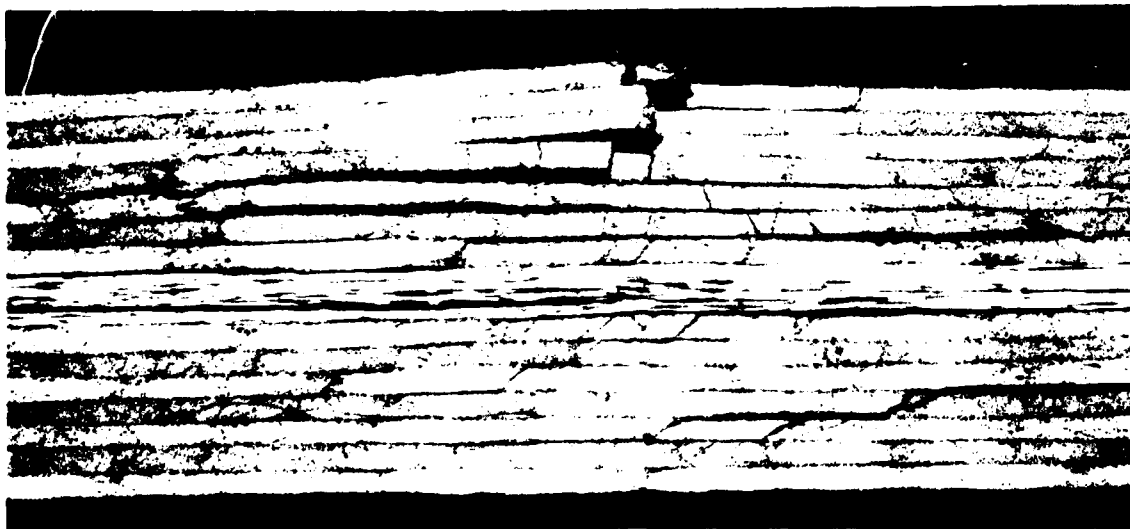
Figure 12: Micrographs of Section across Impact Station of Specimen 20A-2, Subjected to Low Temperature Exposure, Impact, Vibration, Conditioning, Delamination Extends 0.873-inch from Station.
